Brownstone & Masonry Repairs and Exterior Historic Structures Report

Concord Town House

22 Monument Square, Concord, MA 01742

November 8, 2012

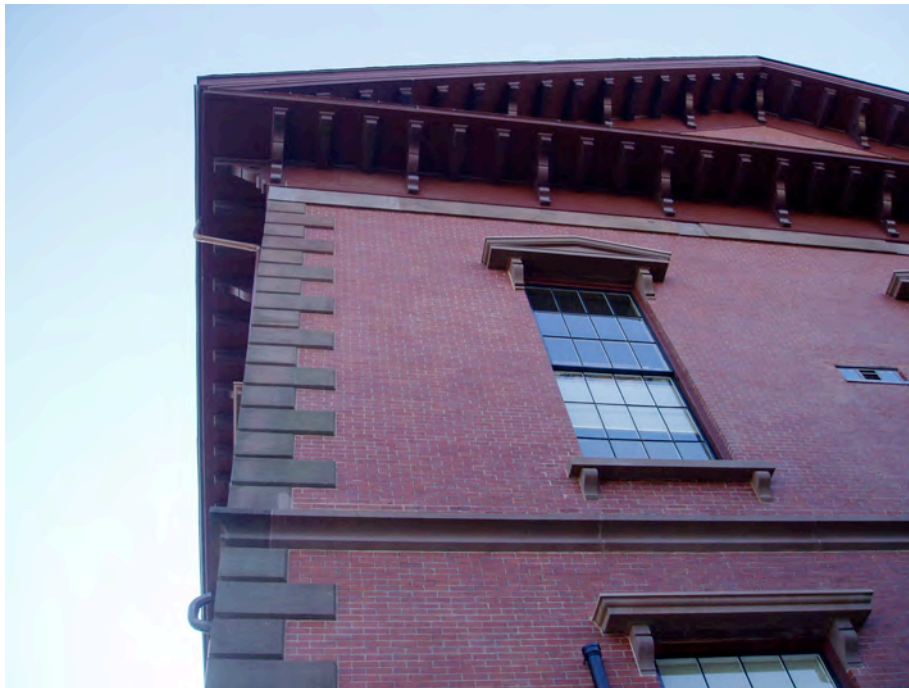
Newburyport Town Hall Restoration -
Window heads, window sills and stringcourse are cast stone.
Quoins are original brownstone.

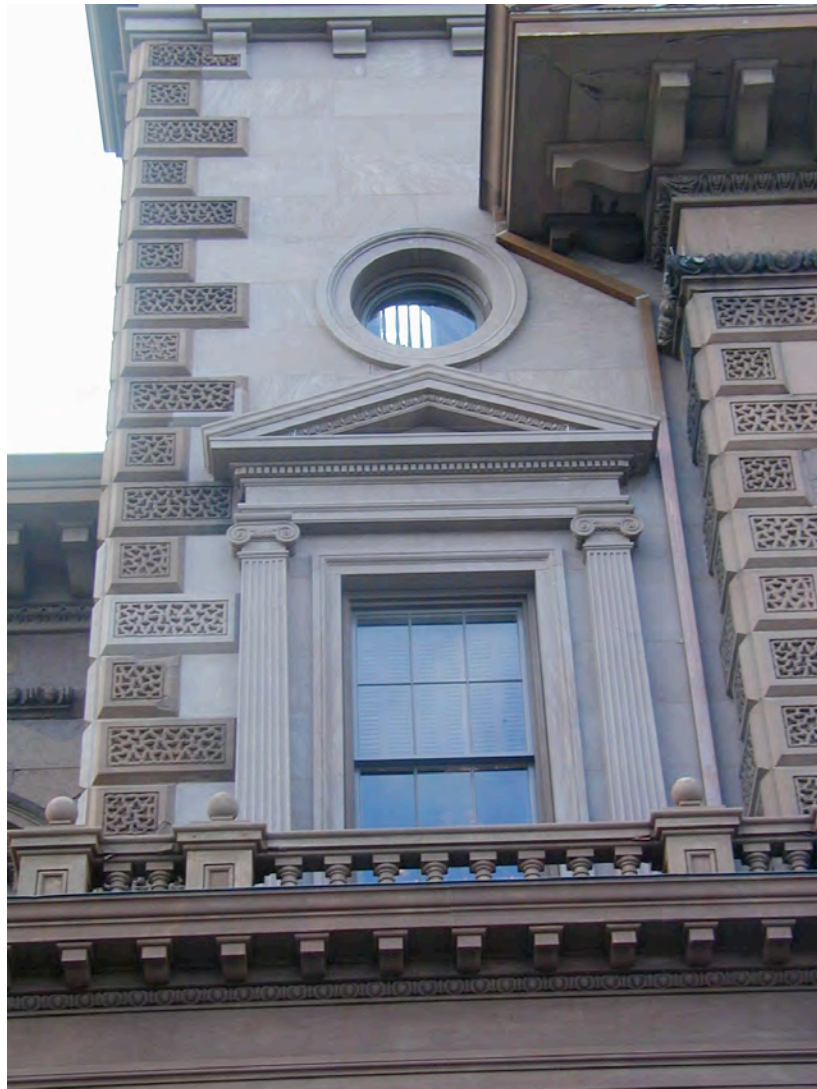
Completed brownstone restoration at the Victoria Mansion in Portland, Maine.

Quoins are repaired with full and partial dutchmen.

Ashlar units and pediment over window as well as pilaster columns and capitals are new brownstone - Note the difference in color between the weathered original stone and the new Portland Brownstone
